Manhole Inspection Summary

Manhole # S33WW1002MH

Insp Date: **1/29/07 9:23 AM**

Location Address: **5110 SPRINGLAKE WAY**

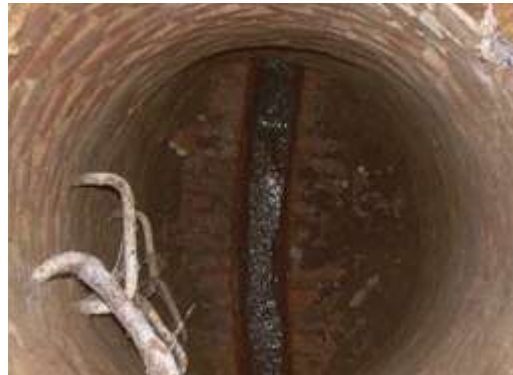
Top View

Bench debris.

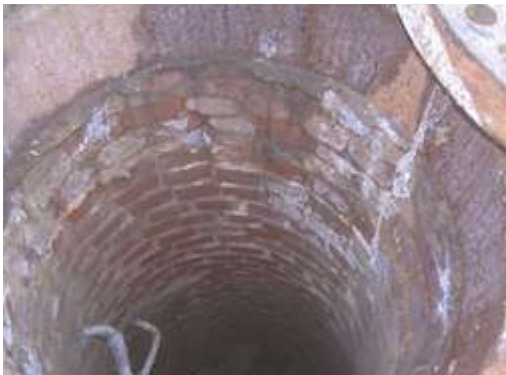
Defect

Condition: ☐ Sound ☐ Cracked ☐ Root Intrusion ☐ Loose Brick ☒ **Deteriorated**

Infiltration: ☐ None ☒ **Joint** ☐ Cracks ☐ Mortar ☐ Roots ☒ **Wall**

Infiltration: ☐ None ☐ Joint ☐ Cracks ☒ **Mortar** ☐ Roots ☒ **Wall**

Adjustment deterioration and infiltration.
Barrel infiltration - other side.

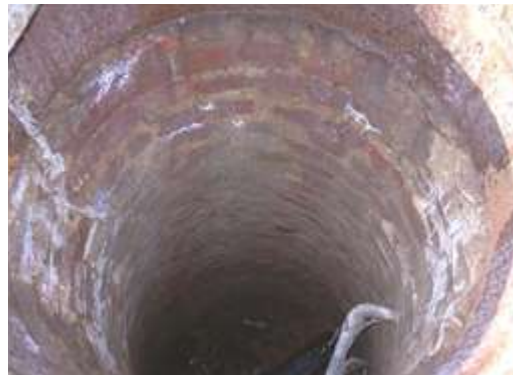
Defect

Adjustment deterioration and infiltration.
Barrel infiltration.

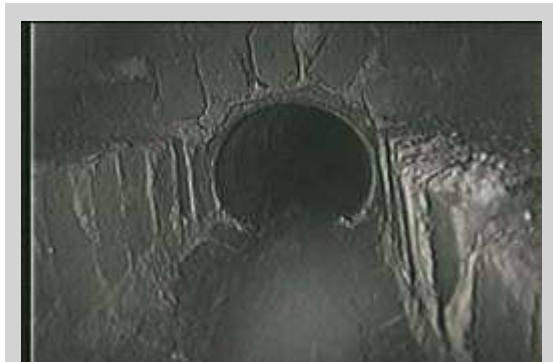
Pipe Out @ 12 O'Clock

Infiltration: **Evidence** Pipe Seal Cond: **Cracked**

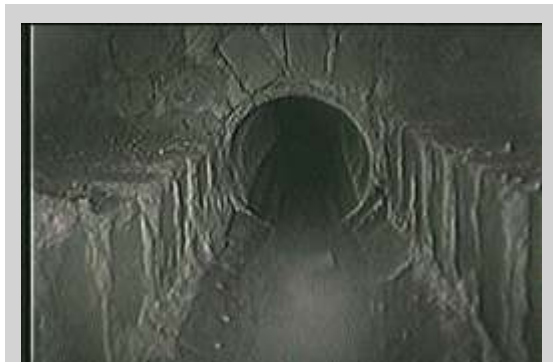
Pipe In @ 6 O'Clock

Infiltration: **Evidence** Pipe Seal Cond: **Cracked**
